REXMONT NO. 2 DAM

NDI NO. PA-00594

LEBANON COUNTY, PENNSYLVANIA

**PHASE I INSPECTION REPORT
NATIONAL DAM INSPECTION PROGRAM**

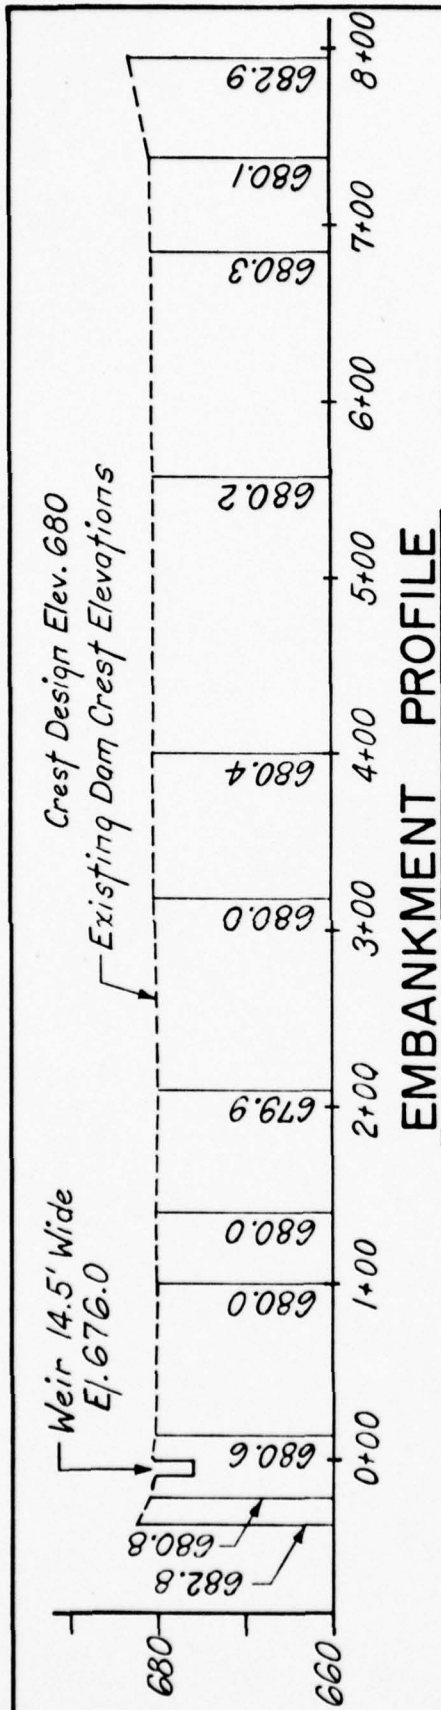
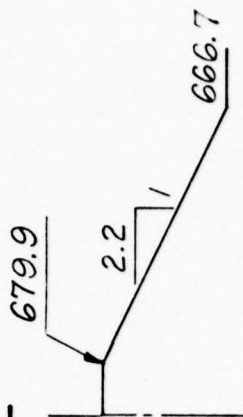
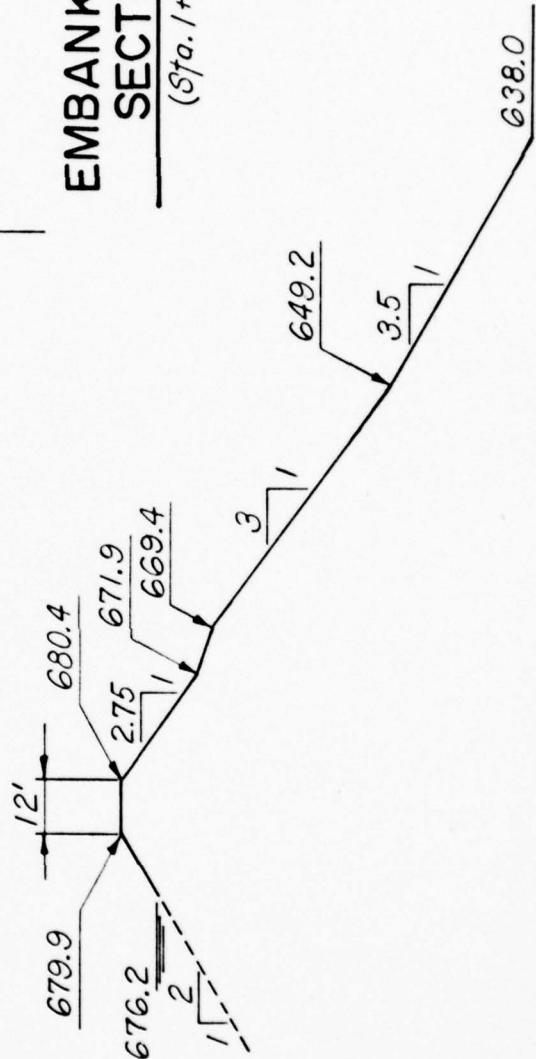
PLATE A-I

The upstream slope is brick paved and appears to be in excellent condition. Above the normal pool level, grass and some weed growth is covering the brick. The top of the dam has high grass and a footpath. The edges are somewhat rounded off and a slight variation in width was noticeable, but this was not considered serious. The horizontal alignment of the dam was good, with a sharp turn near the left end of the embankment. A survey of the dam profile indicates a fairly level embankment with only one point below the design elevation of 680.0 (see Appendix A).

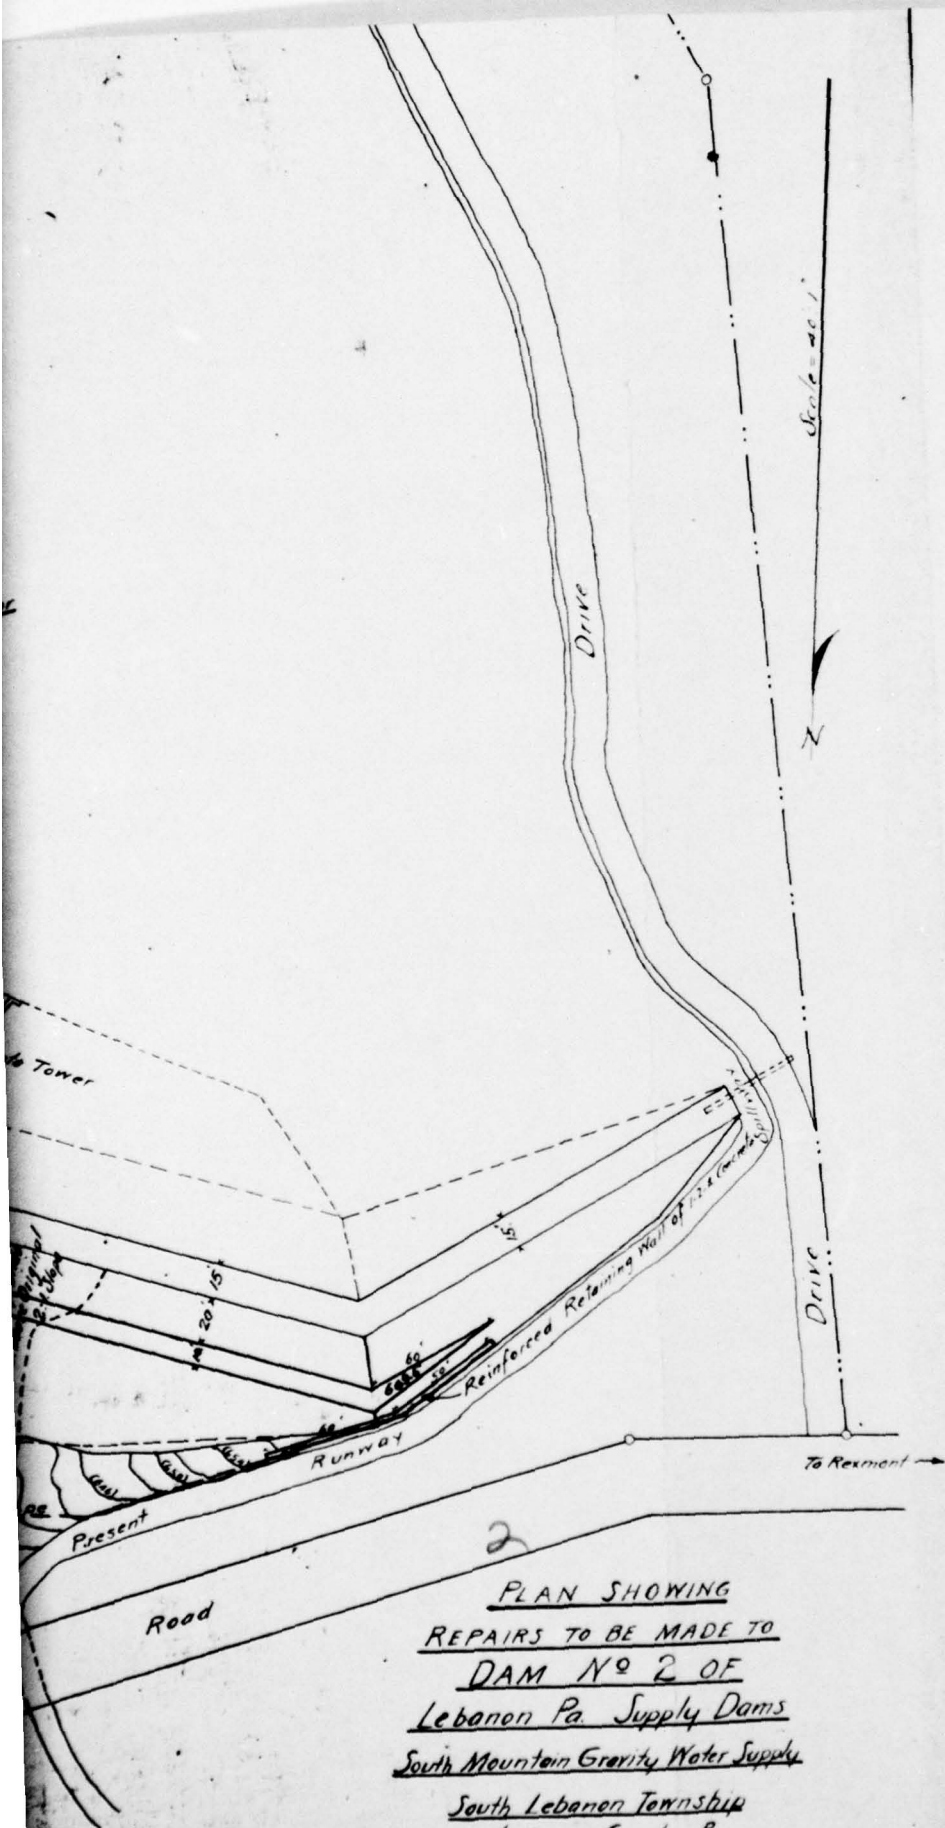
PA. 594
 PLATE VIII

The slide area was backfilled with stone and the spillway crest was lowered 2.5 feet. Although it was recommended to flatten the downstream slope, no changes were made. On July 25, 1925, a serious slide occurred over a length of 110 feet (Plate VIII, Appendix F) at the top of the dam. The width of the slide narrows down to about 70 feet at the toe of the dam. The material flowed beyond the toe over a length of 150 feet, pushing over a wire fence along the highway. Maximum depth of the slide was about 10 feet with a nearly vertical upstream edge and showing distinctly the horizontal layers in the embankment. Considerable seepage appeared to be coming from the embankment with the water in the reservoir at normal pool level. The material of the slide was soft and saturated and could not bear the weight of a person on July 27, 1925. The estimated maximum reservoir level was 2 feet above spillway crest. The slide area was backfilled in the summer of 1925 with stone.

2
PLAN SHOWING
REPAIRS TO BE MADE TO
DAM NO 2 OF
Lebanon Pa. Supply Dams
South Mountain Gravity Water Supply
South Lebanon Township
Lebanon County Pa.
